NAVAL NUCLEAR POWER UNIT  
FORT BELVOIR, VIRGINIA

Date: 11 September 1973

RASO Report No.: 81

RADIOLOGICAL AFFAIRS SUPPORT OFFICE  
REPORT OF TECHNICAL ASSISTANCE VISIT  
TO HUNTERS POINT NAVAL SHIPYARD,  
SAN FRANCISCO, CALIFORNIA,  
23 - 25 JULY 1973

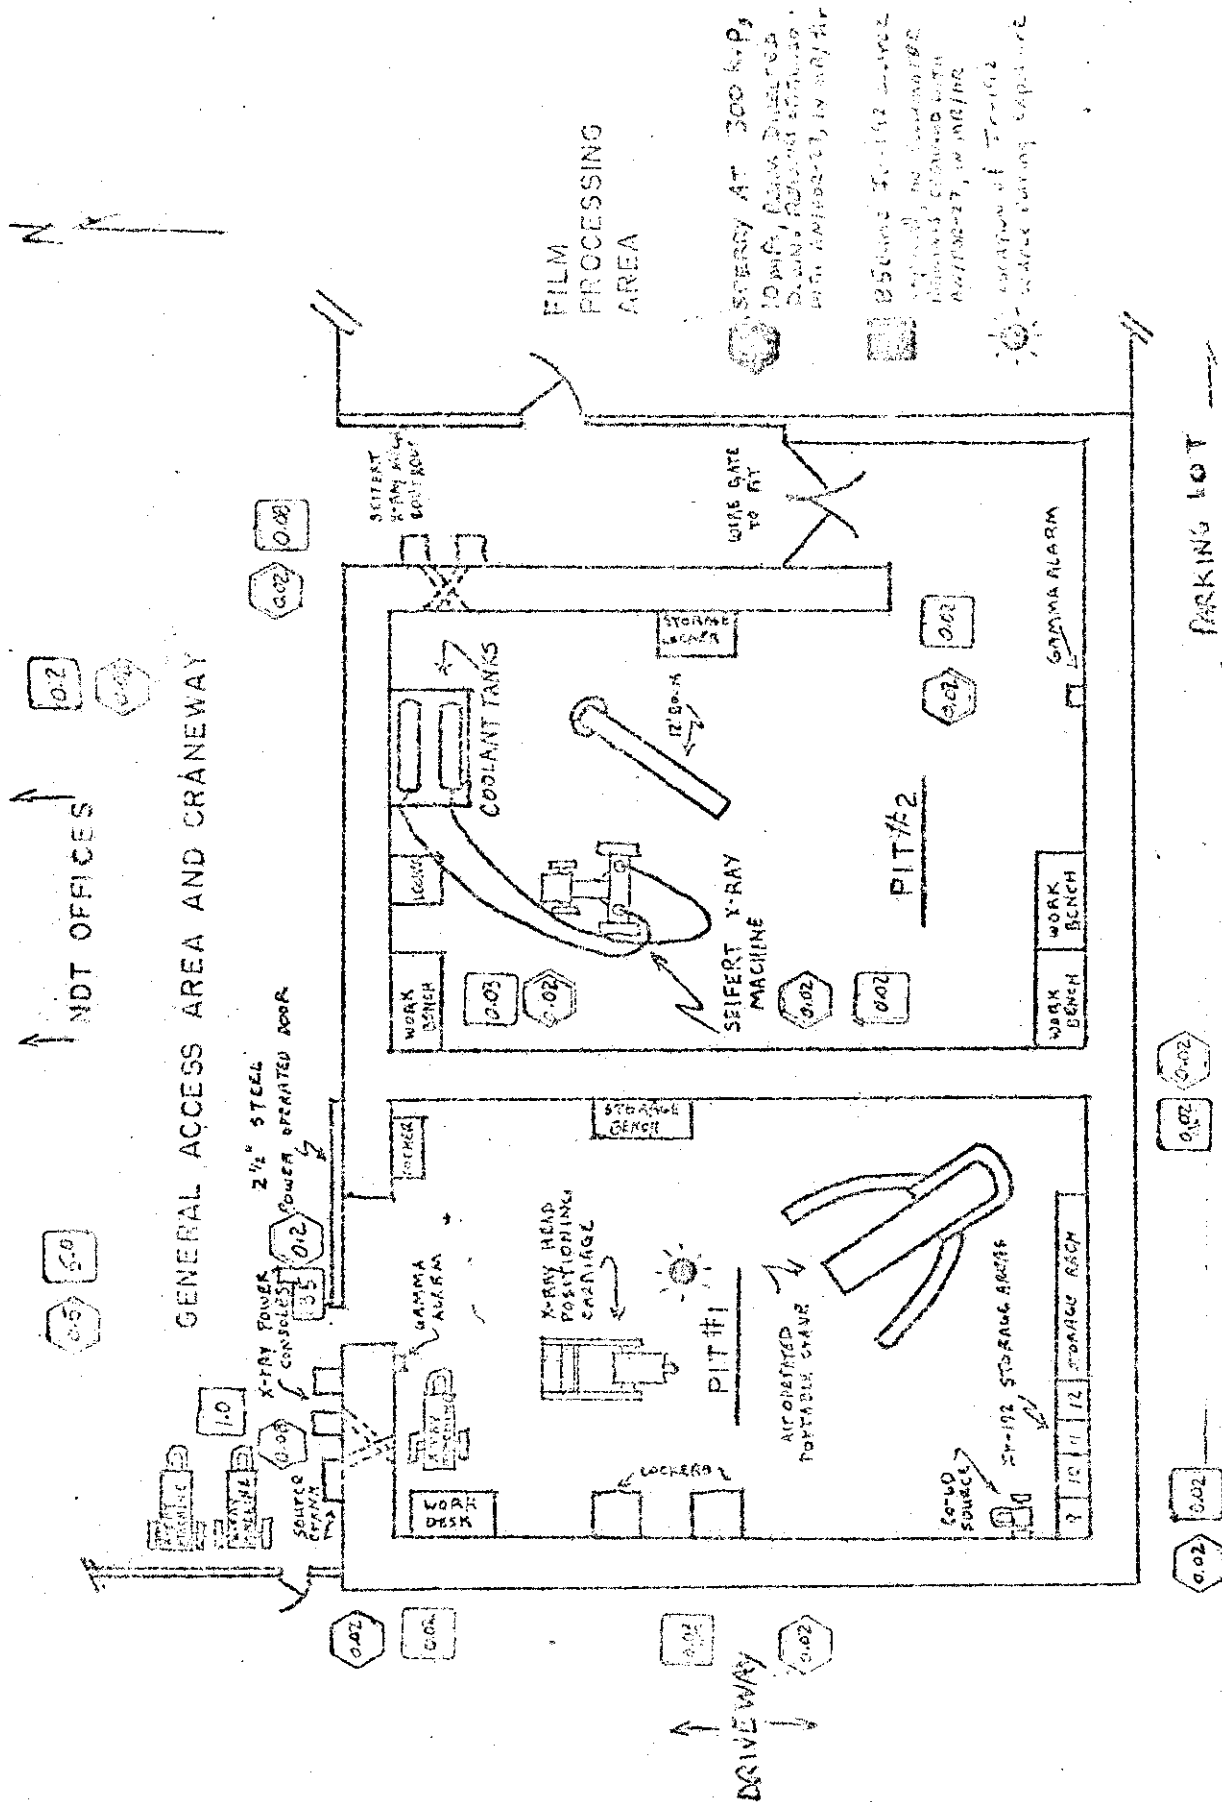
# BLDG 113A RADIOGRAPHY FACILITIES HUNTERS POINT NAVAL SHIPYARD

1. Facility description. Isotopes and x-ray machines were used in stationary and field locations to obtain radiographs. The stationary facilities were established in Building 113A. The building had two 20' by 28' concrete exposure rooms designated pit #1 and pit #2 as shown in Figure 1, Appendix A.

b. Safety system: Entrance to the radiography area was controlled by the radiographer. Warning lights located at the entrance to each pit were wired to Technical Operations Mark II gamma alarms in each exposure room; the light indicated the presence of fields greater than 2 mR/hr. The door to each pit was interlocked with an audible alarm system. Permissible operating conditions, beam orientations, isotopic source limitations, and copies of operating and emergency procedures for radiation safety were posted by the control station of each pit. The facility and all accesses were properly posted.

a. Surveys performed by radiographers during operations were not being recorded.

b. Neither x-ray controls nor power sources were locked when not in use.

1. That surveys be recorded during all portable x-ray radiography operations. Survey records should contain a drawing of the radiography area and include such data as radiation levels, beam orientation, machine parameters, and the location of the operations. This data, along with any previously recorded data should be made available to the RSO.

2. That controls of the power to the x-ray units be locked when not in use.

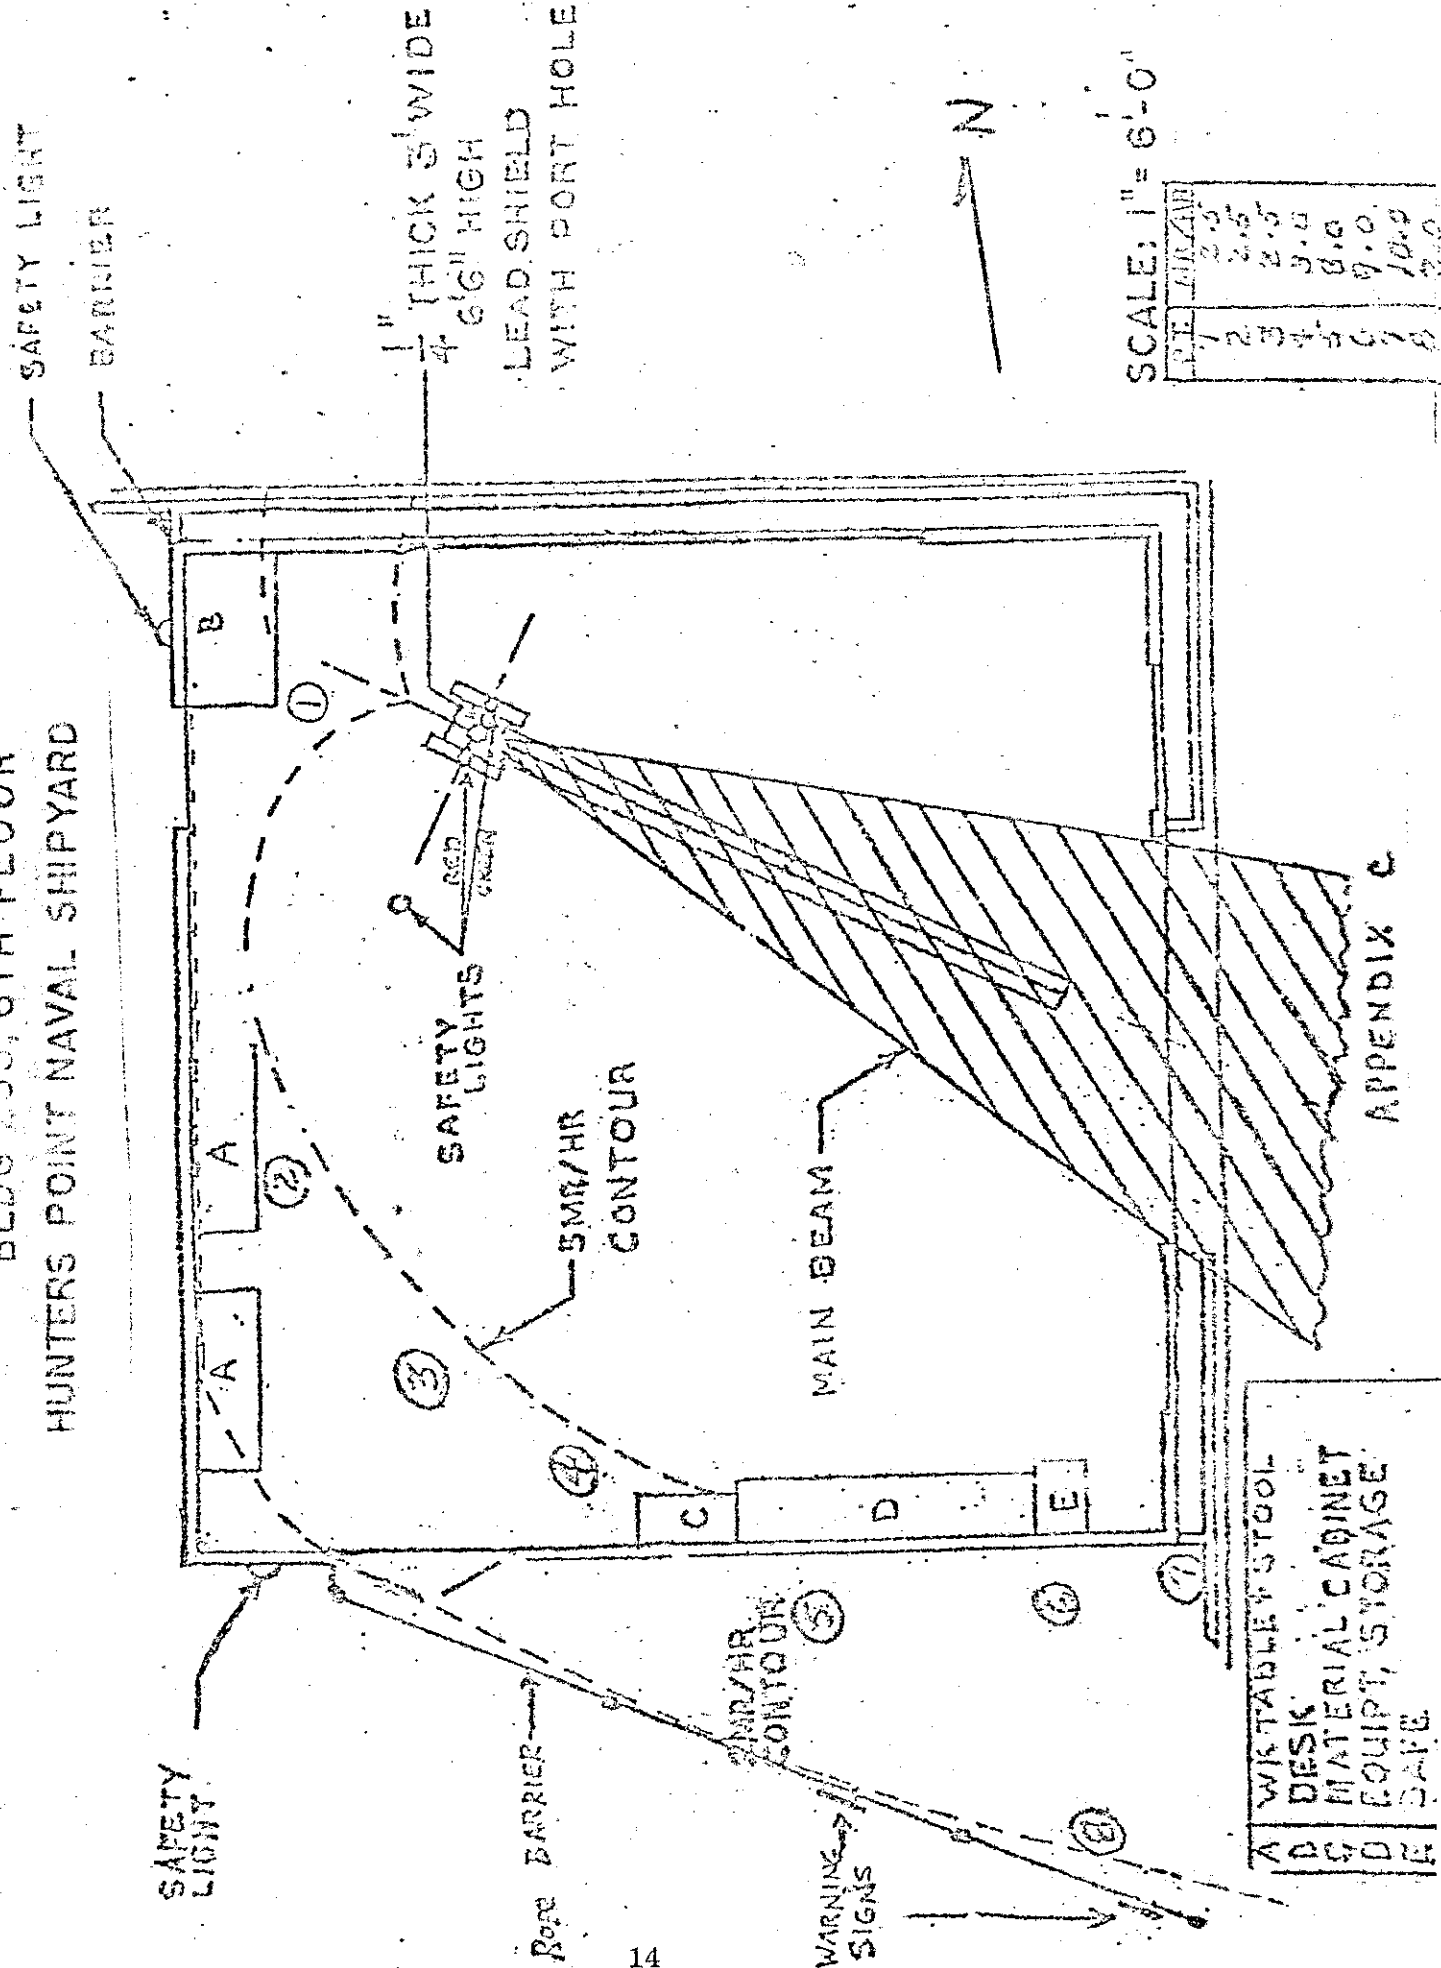
# AN/UDM-1A CALIBRATION ROOM

a. The calibration range was a one room concrete structure located on the sixth floor (roof) of Building 253. The facility was equipped with a 130 Ci cesium-137 source and a 5 Ci PuBe source (AN/UDM-5). A survey of the AN/UDM-1A was performed and the results are included in Appendix C.

b. The AN/UDM-1A was kept padlocked, and the entrance to the site was locked when not in use. When the AN/UDM-1A was in use, red warning lights located above the entrance and on the west wall alerted personnel of the radiation hazard. To control personnel access, a rope barrier was placed at the outside of a painted 2 mR/hr line prior to beginning operations. The door and both accessible sides of the site were properly posted with large radiation warning signs. High radiation area signs were posted inside the facility.

c. A lead shield was placed behind the AN/UDM-1A. The control levers were located at the operator's position behind the shield. Two status lights, located on the shield, were connected to the controls. A green light indicated the source plug was out and a red light indicated the source was exposed. Arrangement and floor plans of the calibration site are included in Appendix C.
